Re: Bay View Reserve Condominiums  
7550 Hinton Street  
Orlando, Florida 32819  
Orange County Parcel ID 326-23-28-0538-00-0001  
UES Project No. 0115.2300271.0000  
UES Document No. 2063363

UES Milestone Inspections, LLC (UES) has completed the mandatory Structural Integrity Reserve Study ("SIRS") as required for condominiums and cooperative buildings for the above referenced property. UES's assessment was performed in general accordance with Florida Statute (FS)718.112(2)(g) (or 719.106(3)(k) for Cooperatives) (effective May 26, 2022) and local requirements of the Authority Having Jurisdiction (AHJ).

### **PHOTOGRAPHS**

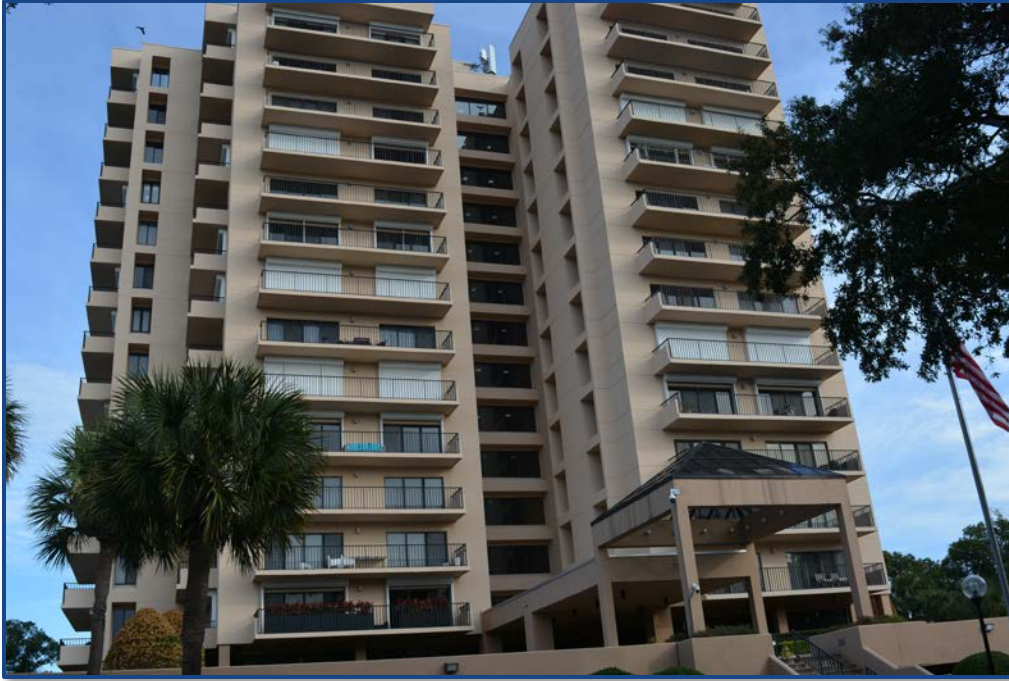
Photograph No. 1: The Bayview Reserve building is 15-stories and currently has good coatings.

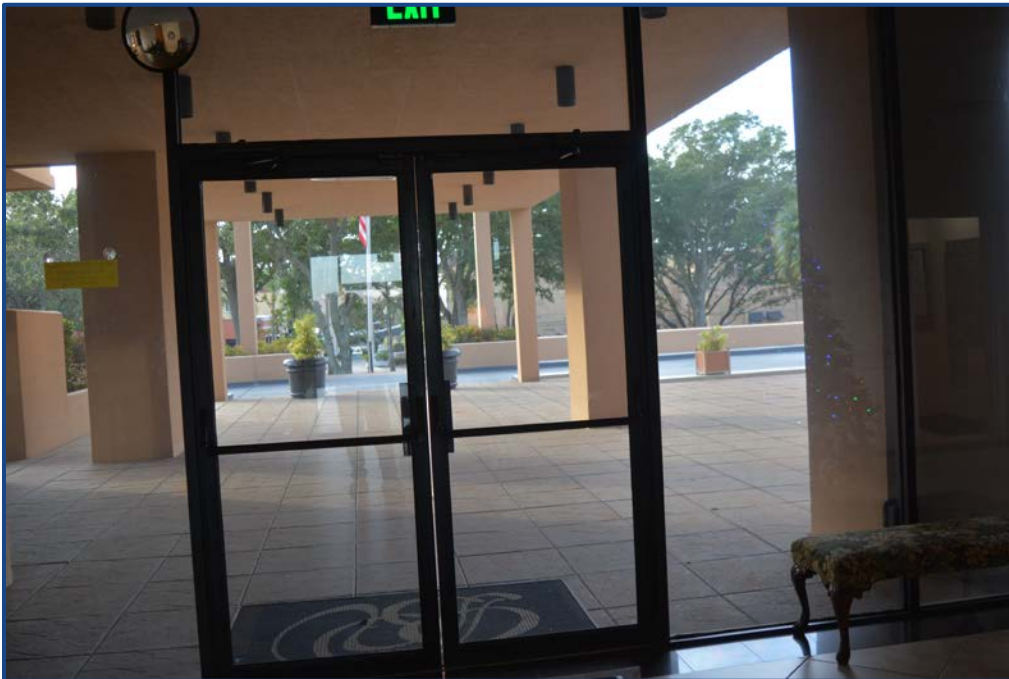
Photograph No. 2: Common element doors include the front entry, fire doors, and other access doors to the building. These have to be in the reserves.

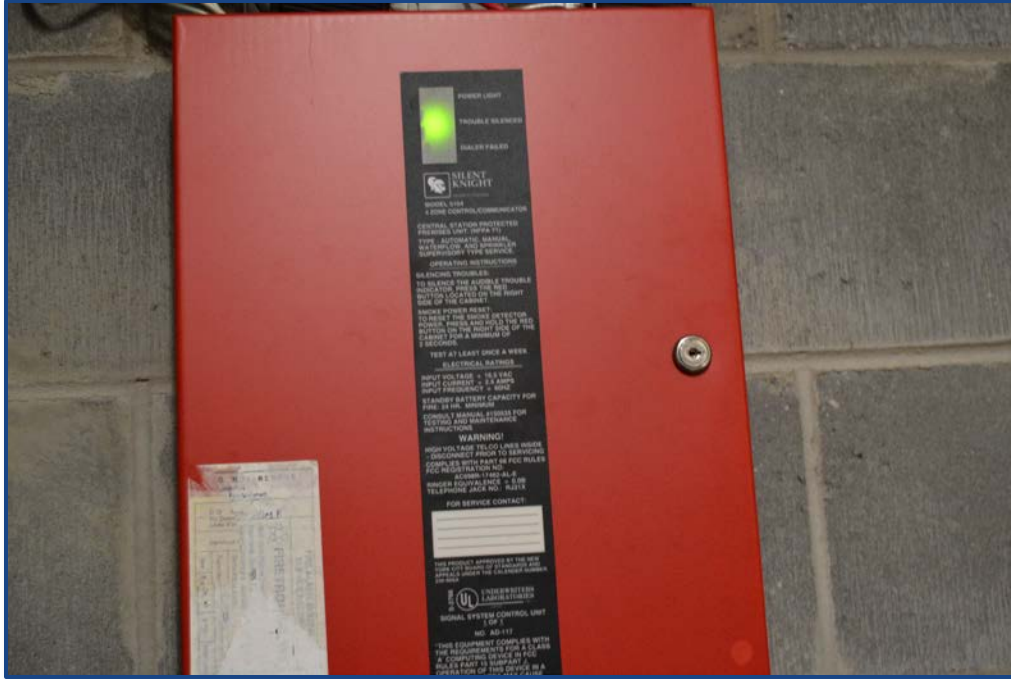
Photograph No. 3: The fire system electronics are in good condition and serviced annually.

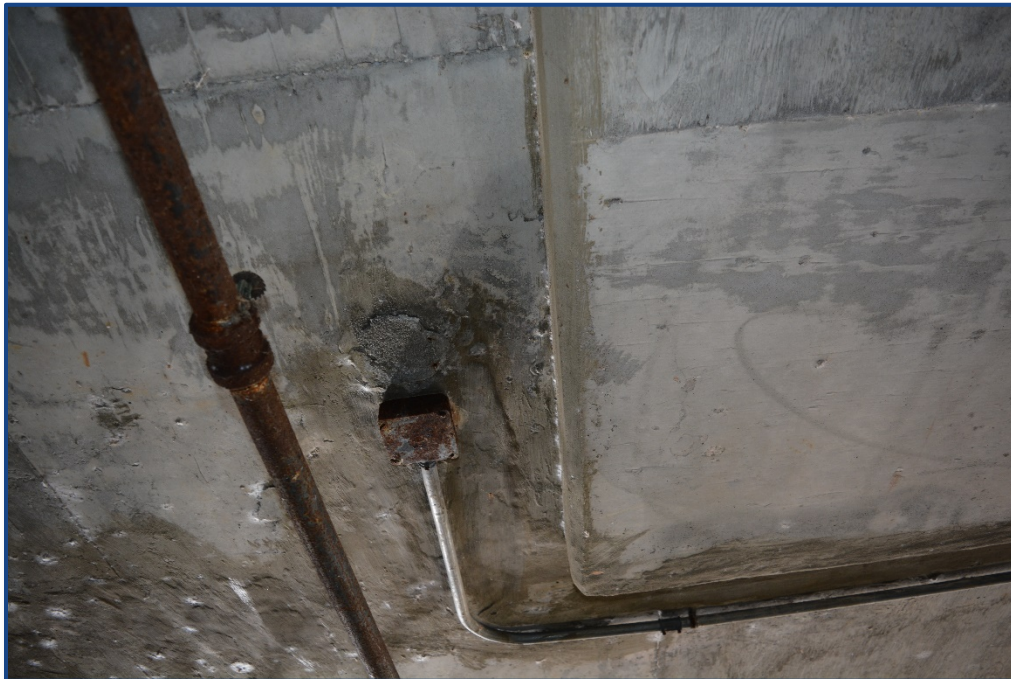
Photograph No. 4: The sprinklers in the unconditioned space have a 40-year design life. Sprinkler heads need replacement.

The building has a complete fire alarm system, and it is in good condition. The fire system controller, extinguishers, and sprinkler heads are inspected yearly at a minimum. See **Appendix A** for estimated cost and estimated contributions required for sprinkler head replacement and fire supply piping cleaning and painting.

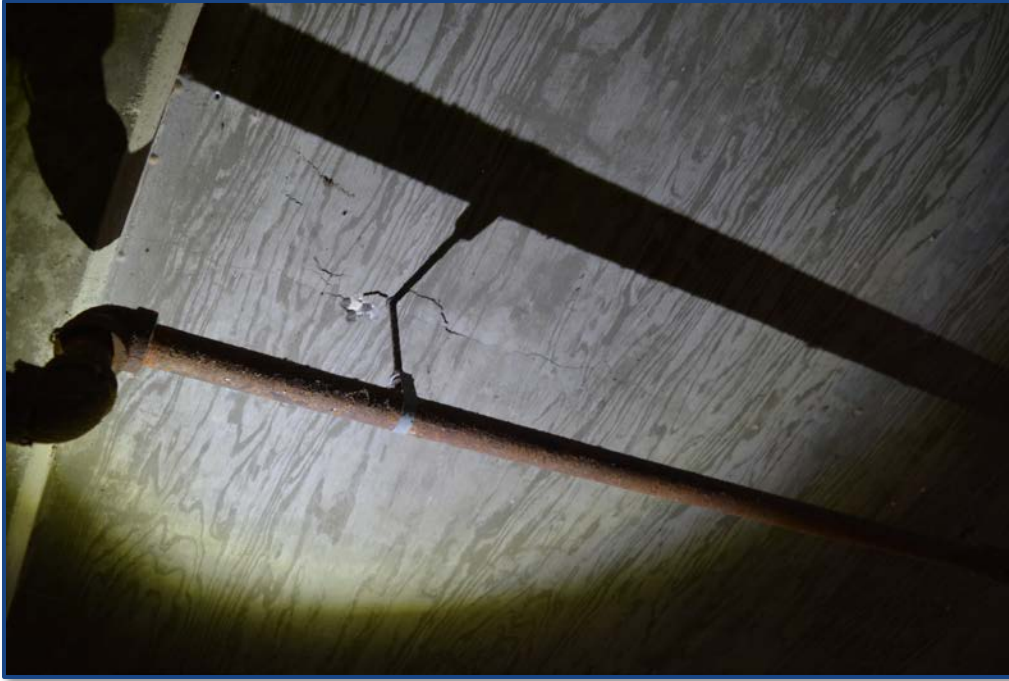
Photograph No. 5: Sprinkler piping in the basement is rusting and will need sanding and painting soon.

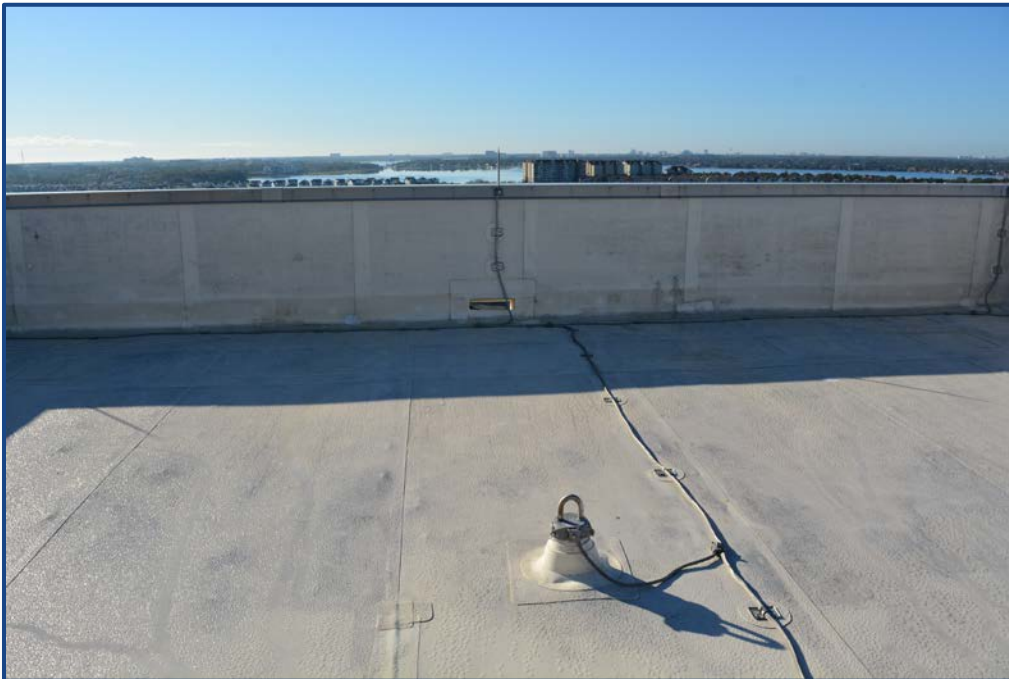
Photograph No. 6: The TPO roof covering is in good condition and its cost shared among the unit owners.

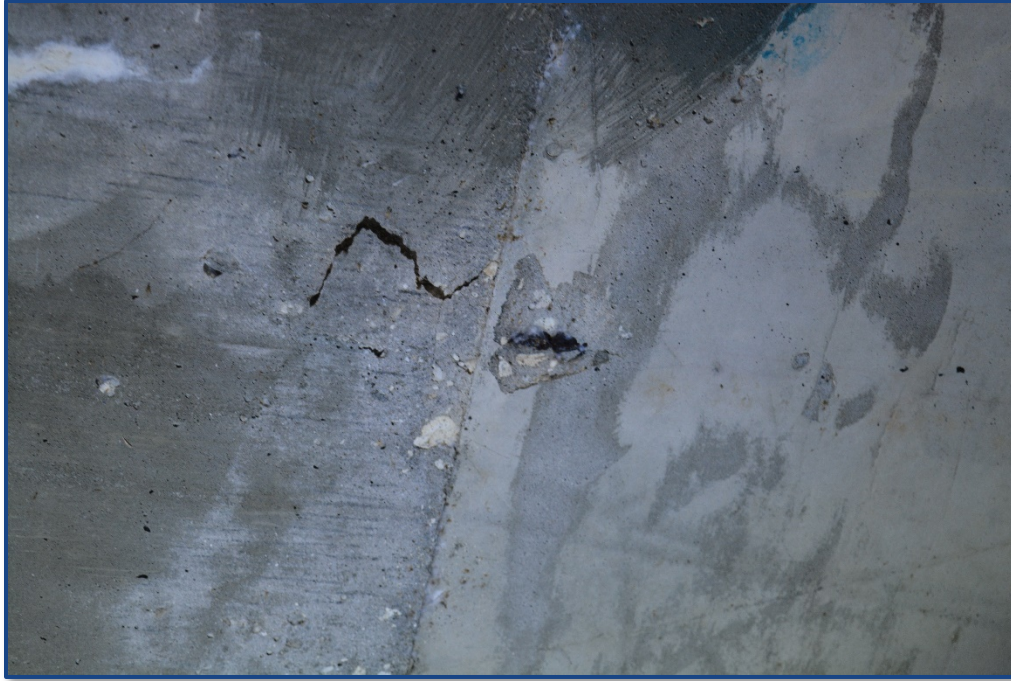
Photograph No. 7: The garage ceiling needs to be repaired when defects occur.

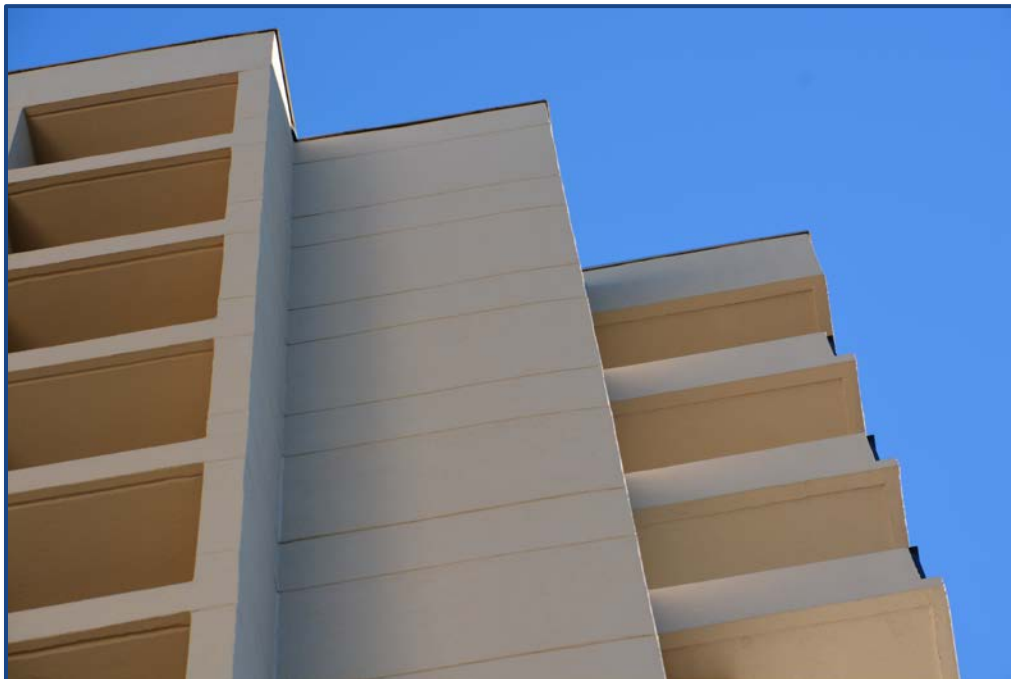
Photograph No. 8: Building waterproofing and painting are to be performed every 7 to 10 years.

Waterproofing and exterior paint have a life expectancy of 7 to 10 years with proper maintenance. Proper maintenance includes pressure washing exterior surfaces with a trisodium phosphate solution (not chlorine), routine inspections of exterior finishes to ensure paint peeling, bubbling and other imperfections are not present, and to seal all cracks and gaps with proper epoxy sealant. See **Appendix A** for estimated cost and estimated contributions required.

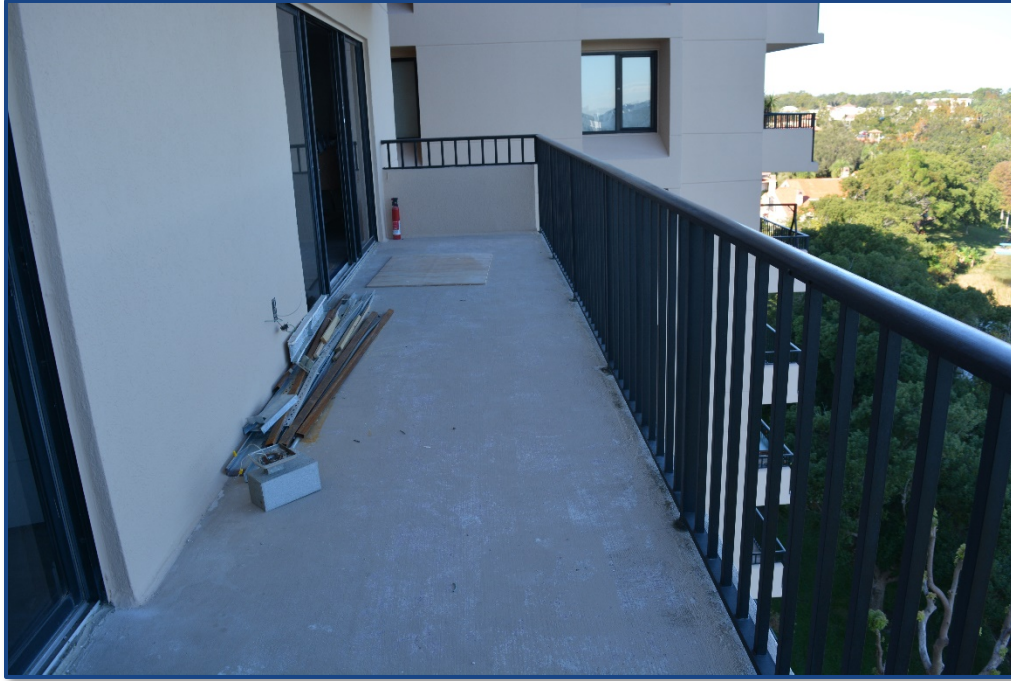
Photograph No. 9: Waterproofing the decks each decade is important to maintain structural integrity of the balconies and guard rails.
